**Towne Square
Facility Assessment
Parkersburg, WV**

Prepared for the Wood County Commission

May 19, 2003

Re: Towne Square Facility Assessment
Architect's Project Number 12527.112

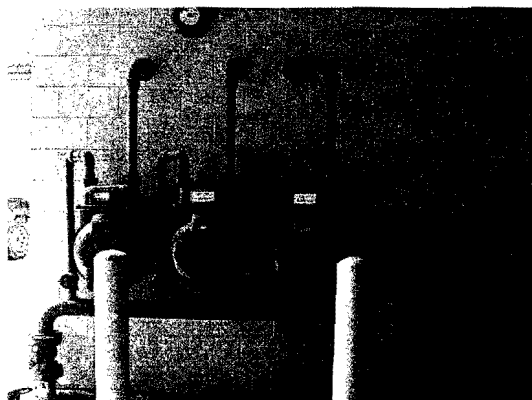
The natural gas service is located on the building exterior at the Northeast corner of the building. It consists of a 4" utility riser pipe manifolded to three 2" meters. Assuming an inlet pressure of 1 PSI and a maximum pressure drop of .3 inch WC, each metered service should be capable of providing 600 Cubic Feet of gas per hour for a total heating capacity of 1,800,000 BTU per hour. This capacity provides 48 BTU/SF which exceeds the 40 BTU/SF recommended for office space.

Existing Gas Service

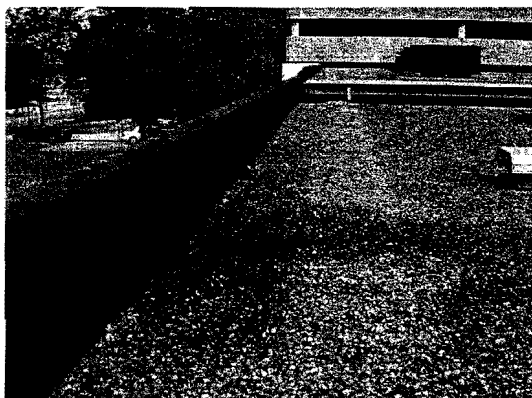
- Age of the roofing membrane.
- Shrinkage and pulling of the membrane in the restaurant area (see photo below).
- Pooling water at parapet wall in line with roof drains (inadequate slope to the insulation – see photo below).
- Multiple locations where the insulation has been “crushed” into the roof deck.
- Adequacy of roof drains is questionable as no overflow drains or scuppers were apparent.

Ponding of Water on Roof

Due to the age of the roof, as well as the conditions noted above, **ms consultants** recommends the installation of a new roofing system, including, but not limited to, new roof insulation, new fully-adhered roof membrane, new overflow drains and/or scuppers, as well as the replacement of all related sheet metal flashings, reglets, and copings. The new roofing system should be supplied with a minimum twenty- (20) year warranty.

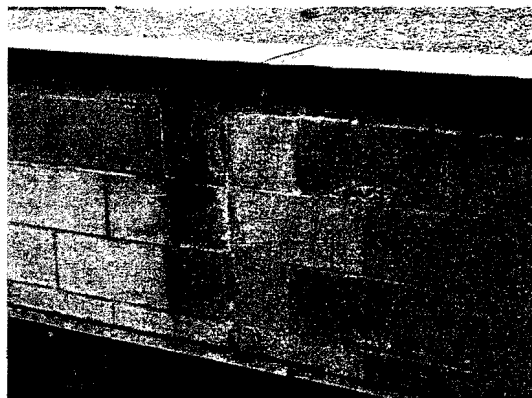
Deteriorated Metal Coping

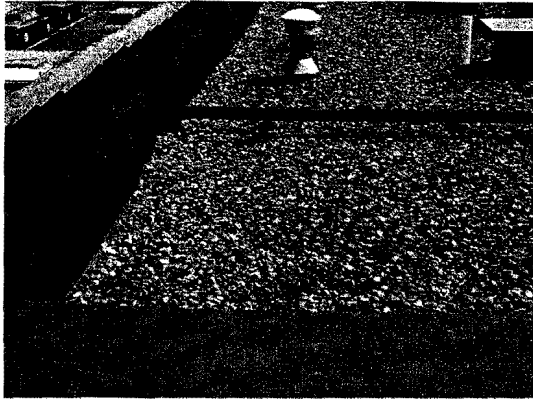
Shrinkage and Pulling of the Membrane

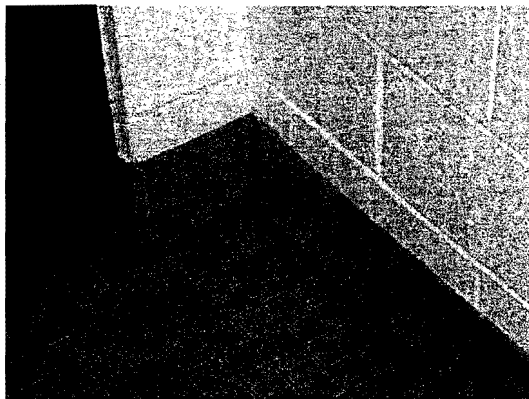
- The floor slab has settled in the corner of the men's restroom (public, adjacent to the garage exit) near the janitor's closet (see attached photo).
- Major problems with slab settlement have occurred in the restaurant area adjacent to the raised platform.
- Some cracking is occurring from the point where the new raised slab for one of the added theatres was placed. This cracking may be due to the additional weight of the new slab.

Slab Settlement - NE Men's Restroom

The areas where floor slab failure has been identified will need to be removed. Once the floor slab has been removed, the compacted base will need to be examined and re-compacted before a new slab is placed.

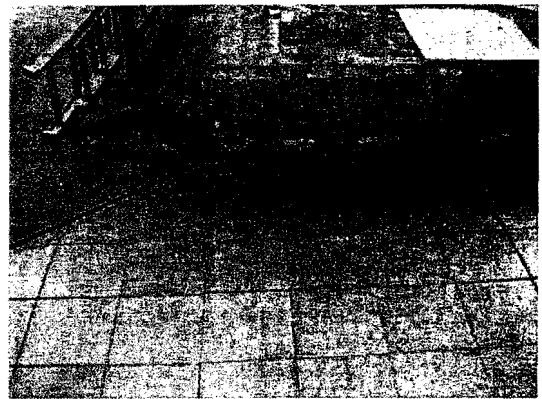
Slab Settlement - Restaurant

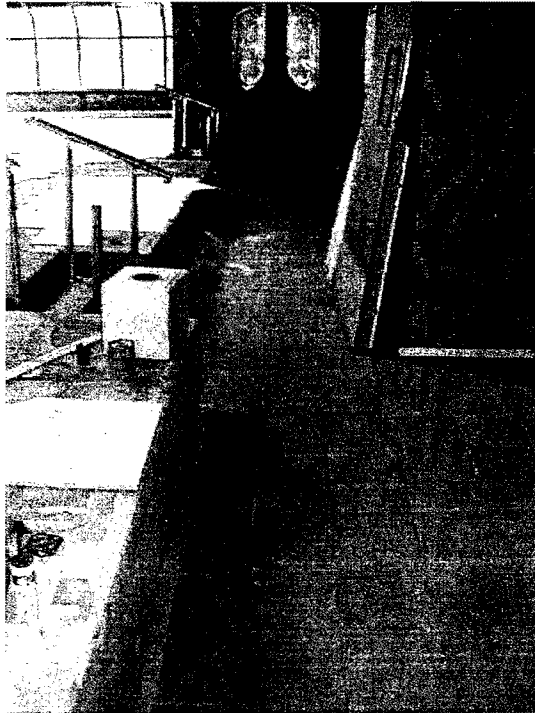
Extent of Settlement in Restaurant

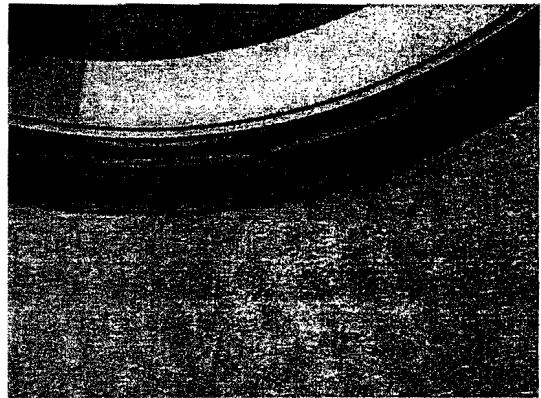
The exterior finish is a Direct Applied Exterior Finish System. The system appears to be vented at the entrance overhangs, and appears to be in satisfactory condition, although cleaning is required to prevent continued deterioration.

Exterior Finish System Discoloration

New finishes will need to be provided which are appropriate for county office space. All vestiges of the current commercial use of the space will need to be removed. Security, life cycle cost, as well as visual and audio privacy will play a large role in the selection of new finishes. Additionally, a new color is recommended for the exterior of the building that would be a close match to the Wood County Courthouse. The new finish will also allow for seamless exterior renovations.

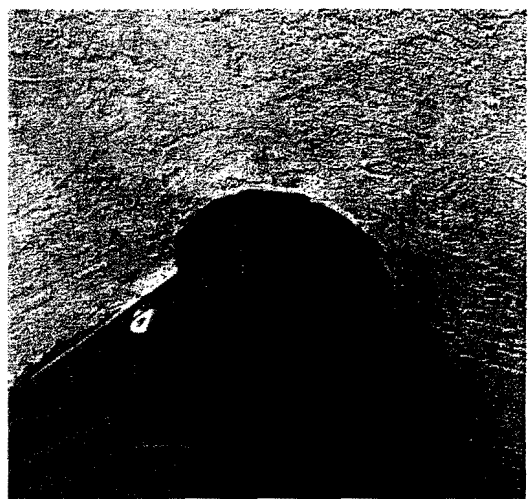
Exterior Finish System Discoloration
