IN RE: MINUTES OF MEETING HELD
MONDAY, AUGUST 9, 2021

RE: Engineering Inspection
Inspection Date: April 9, 2021
Subject: Wood County - Abandoned and Dilapidated Building Ordinance
Location Type: Private Residence
Address: 3432 Elizabeth Pike
Mineral Wells, WV 26150
Owner: Charles Beeson c/o (Current Tenants Reside in the Home)

**the property owned by
Charles Beeson
3432 Elizabeth Pike
Mineral Wells, West Virginia**

Claim Number: 920895-GL

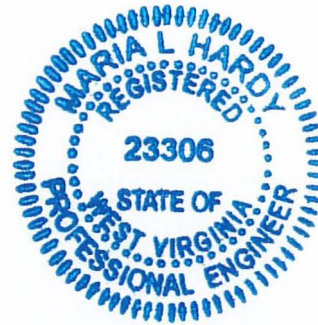
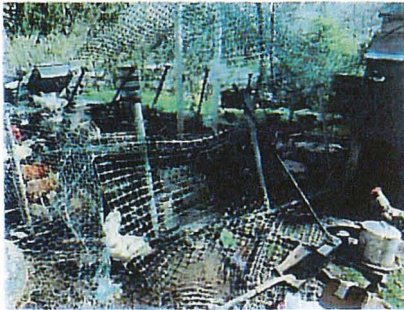
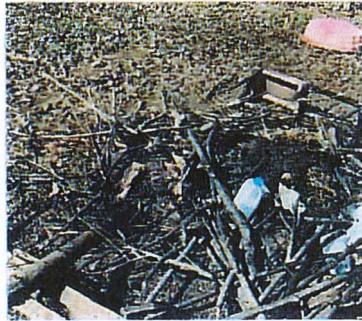
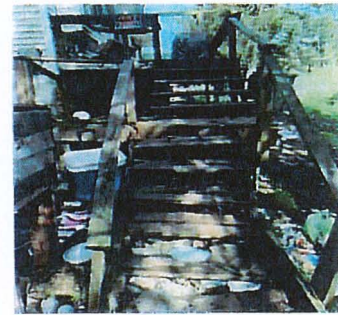
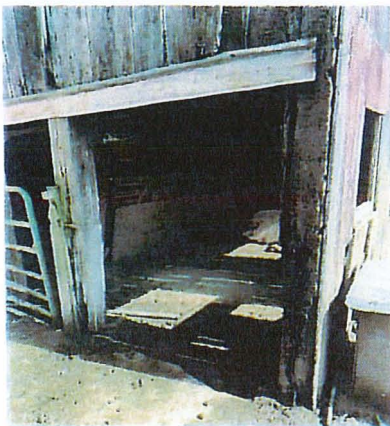
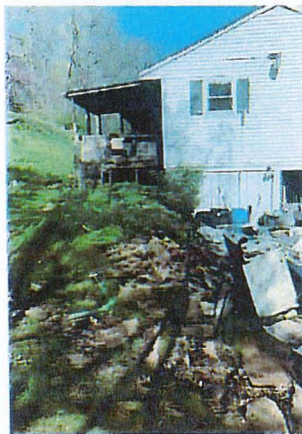
Outside of Home

The inspection findings outside of the structure, included but were not limited to: an open chicken coop with approximately 20 chickens that was in the home entrance path, bunny cages that were also in the entrance patch, both rear egress entries/stairs were dilapidated, both stair access entries also contained debris blocking access. There was a barn in the rear of the structure that contained two live pigs and one partial burnt pig left in the same area which had no gate. Throughout the yard children's toys, clothing and trash was scattered on the premises. The exterior yard also contained a large amount of septic residue from the animals' fecal matter. Human fecal matter is anticipated in the yard as well.

The recommendation is to condemn the home, close all accesses to the home and refrain from any entry into the home by action of the County Engineer. Access may be granted temporary only after a an approved action is provided by the Owner and approved by Wood County Engineer.

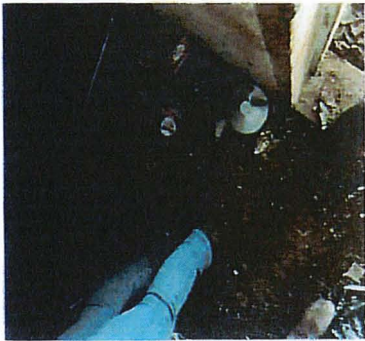
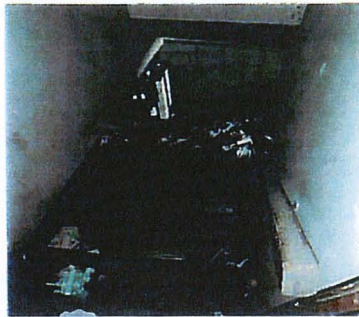
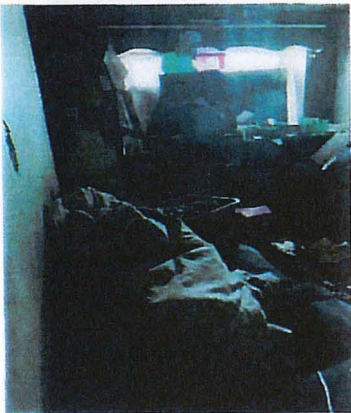
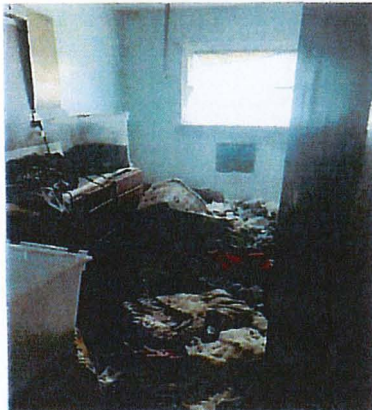
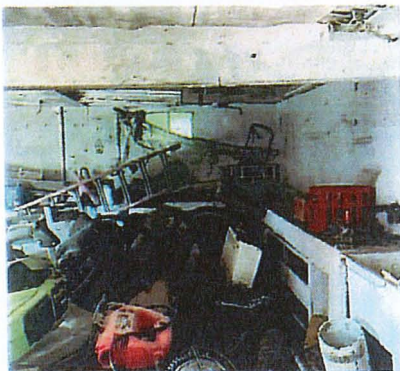
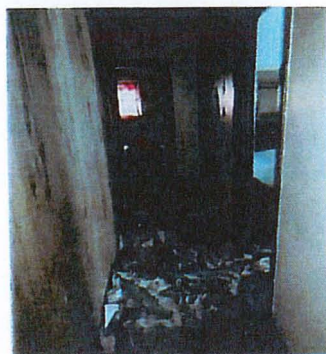
Inside the Home

The only accessible entry was found from the basement. The basement was covered in dirt and trash. The stairs inside the home were covered in dirt on top of carpet. The home was filled with trash debris and clothing for the entire square footage of the home. The bathroom facility was unusable and the septic is anticipated was dumped. The clothing is wet, mildewed and the entire home major structural features were not able to inspect due to all of the debris. The septic smell inside has become toxic with vermin infestation.

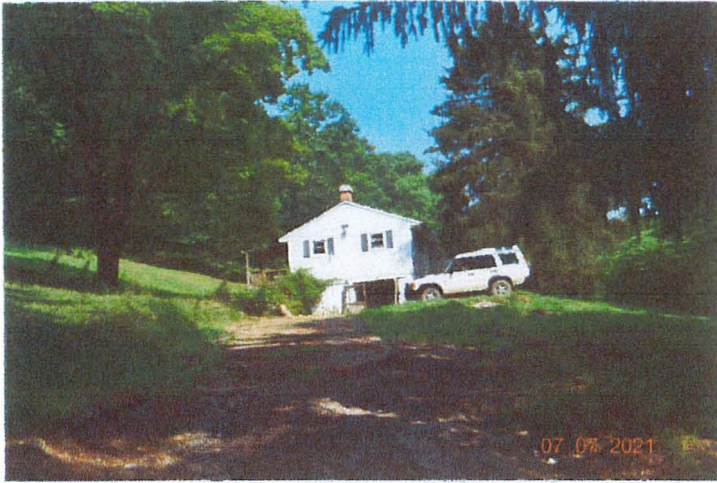
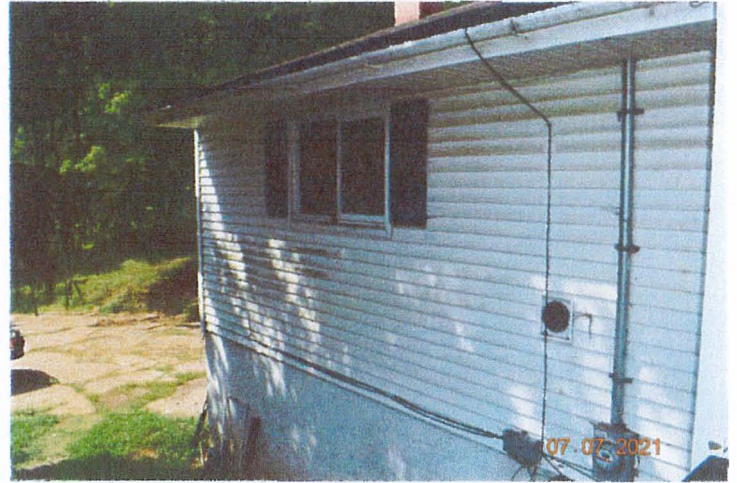
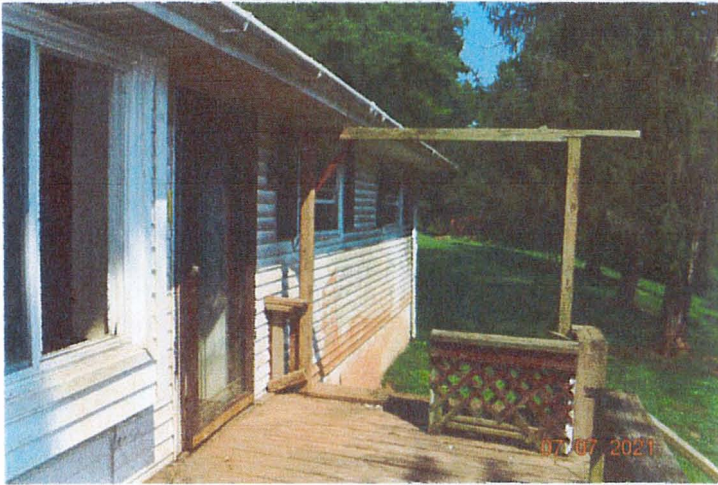
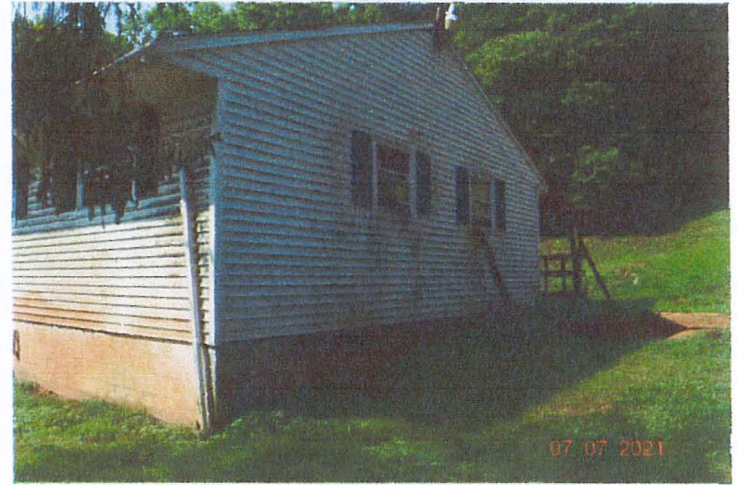
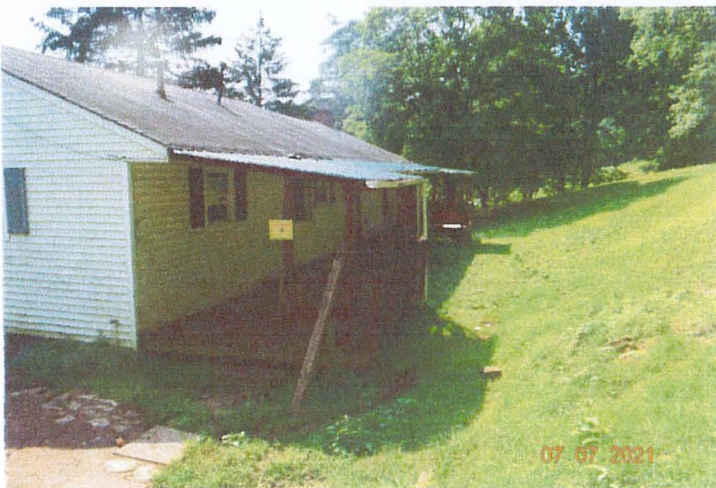
Photographs taken during the inspection are included in Appendix B. Exterior views of the home are shown in photographs 1 through 5. Satellite imagery from Google Earth revealed an extensive amount of trash around the home. The insured performed extensive work to remove this trash from the grounds and interior. The hillside slopes downhill toward the rear of the home. A shallow diversion ditch has been filled with leaf litter and vegetation due to a lack of maintenance. The insured indicated that his grandson would not regularly cut the grass and failed to clean out the ditch. As a result, the ditch has not been functional, which allows surface water to accumulate around the foundation.

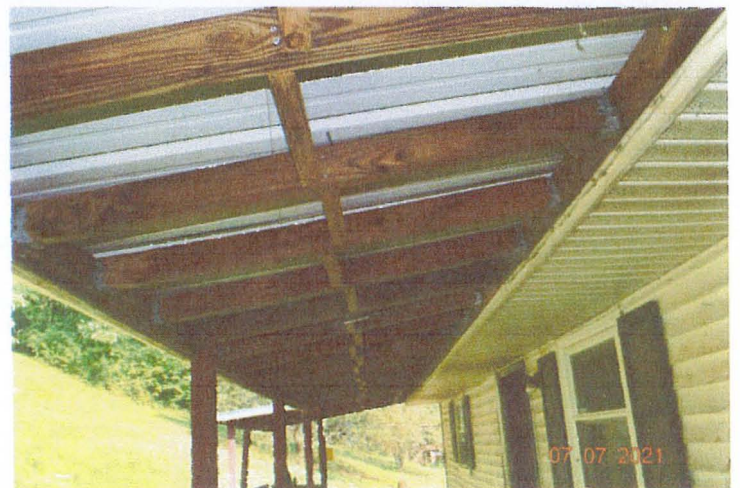
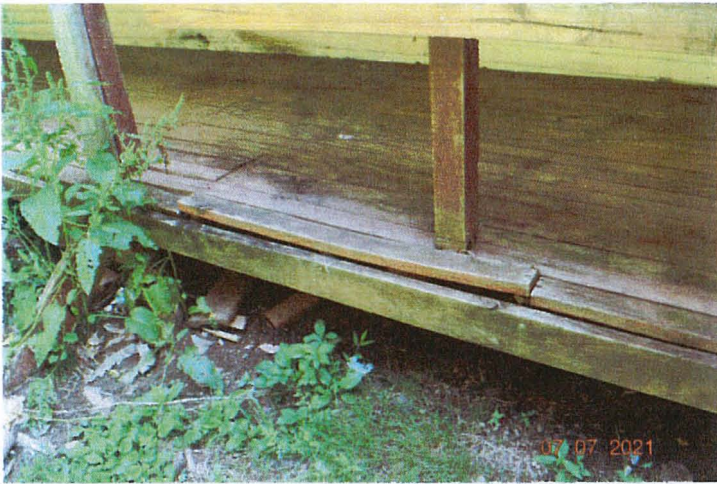
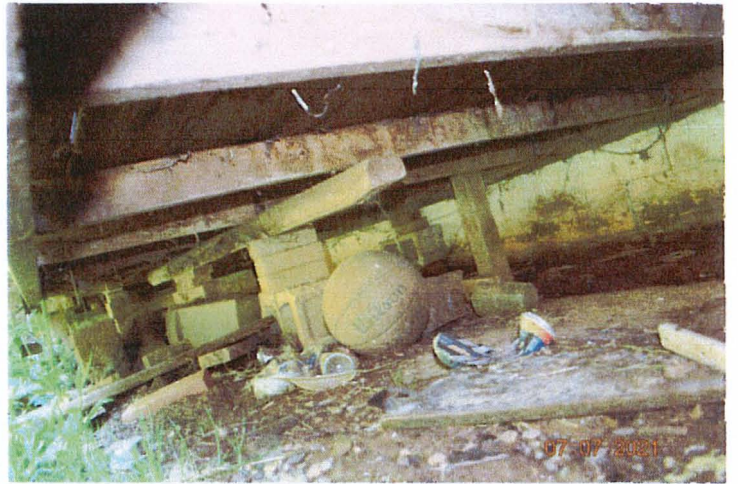
The roof and floor frames of the rear deck are shown in photographs 6 through 8. Access stairs at the center of the deck are deteriorated and unsafe. The roof frame is in fair condition. However, the design involves connecting the ledger board to the fascia. Often, fascia boards are

composed of 1x lumber, which is not suitable for a structural connection. The deck includes warped deck boards, raised nails, and weathered surfaces. Efforts to stabilize or raise the floor joists were noted beneath the deck.

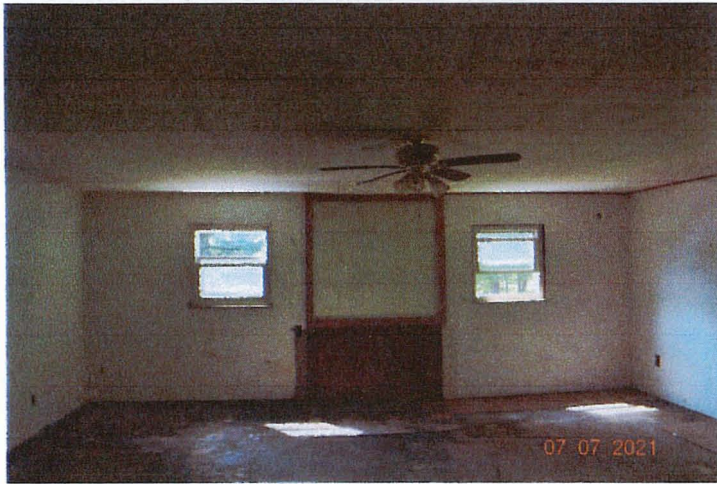
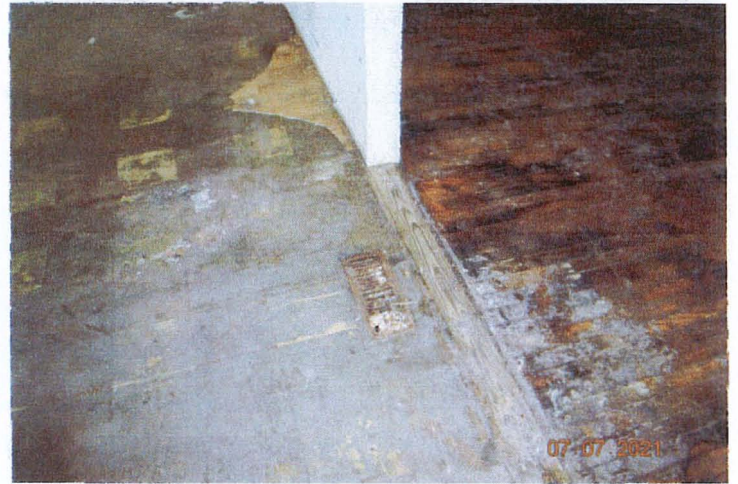
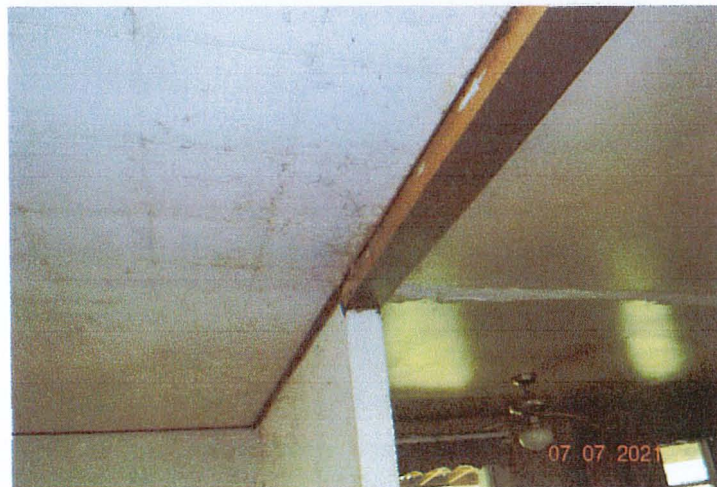
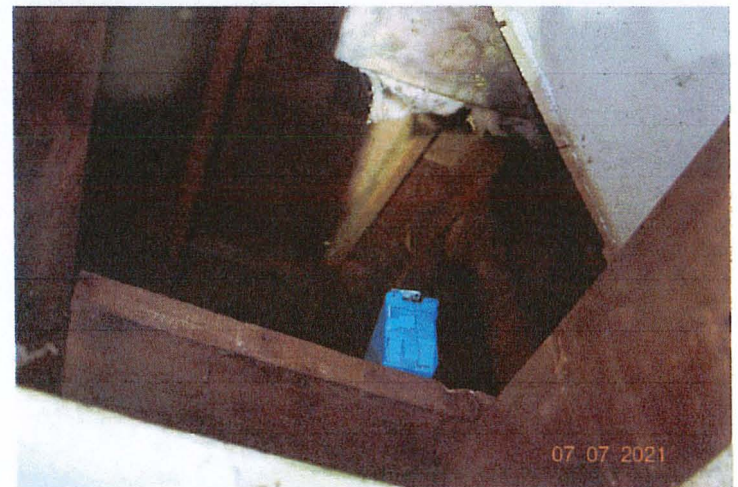
The family room, which is situated above the garage, is shown in photograph 9. Photographs 10 and 11 detail the transition line along the right side of the living room. The floor exhibits a large sag across the center line. Measurements indicate a total deflection of 2.25 inches at the midpoint. The floor is lower at the left end than at the transition line, which may be a vestige of construction. Post-construction settlement may have also contributed to the out-of-level condition. The attic space as seen through the access hole is shown in photograph 12.

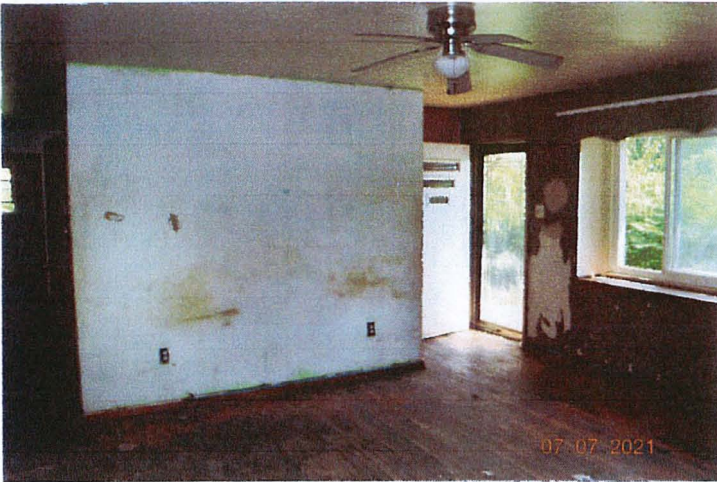
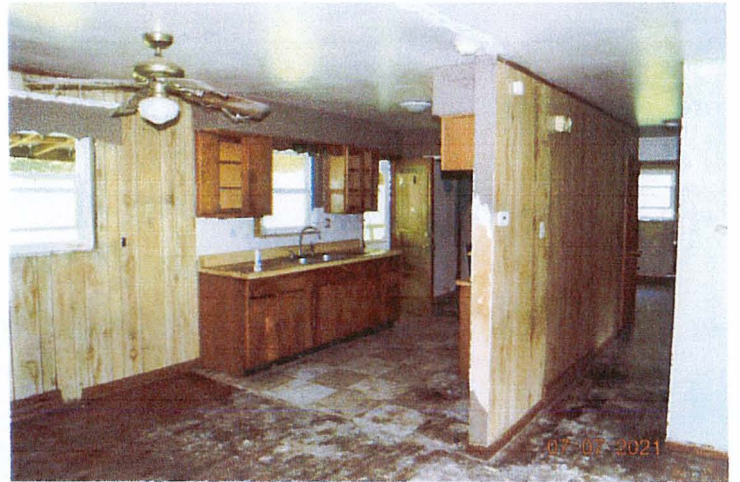
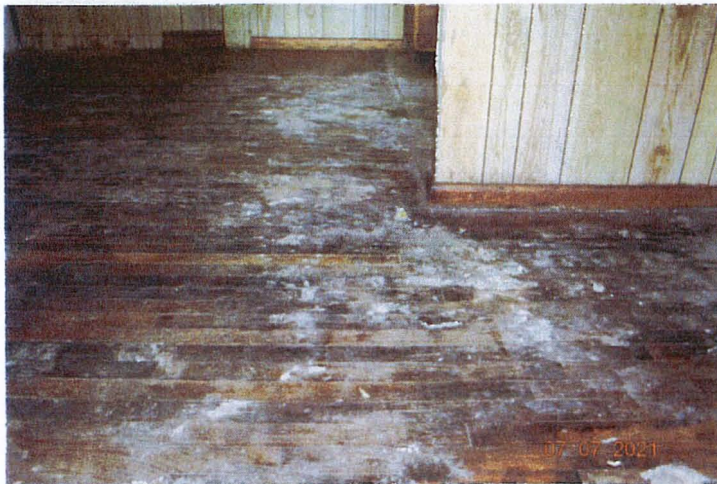
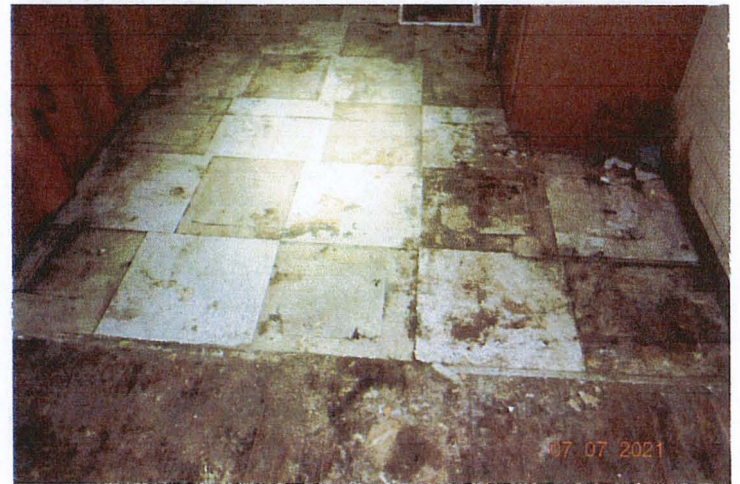
The living room, dining room, and kitchen are shown in photographs 13 and 14. The dining room floor slopes down at a rate of 3/4:48 toward the kitchen. Photographs 15 and 16 detail views of the dining room and kitchen floors. The storage of trash in the home resulted in significant damage to the interior finishes. The flooring should be removed as these materials are not salvageable. Moreover, the finishes may be obscuring hidden decay or infestation damage to the framing elements. It is recommended that the interior be gutted, including all drywall, trim-work, and cabinetry, to properly repair the home. The air ducts should also be removed and replaced.

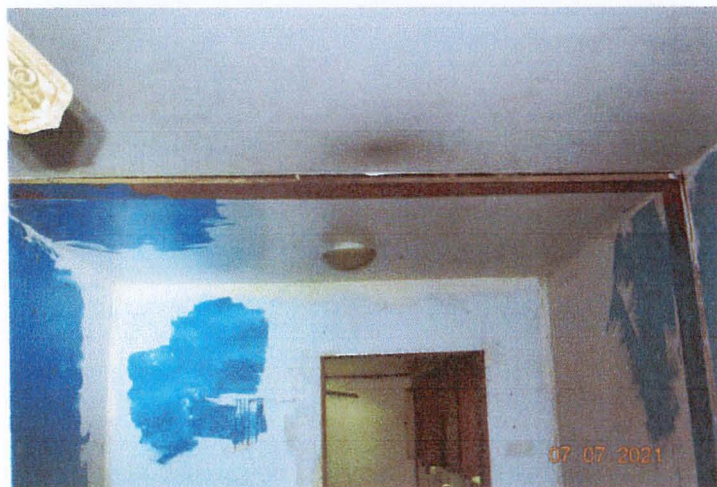
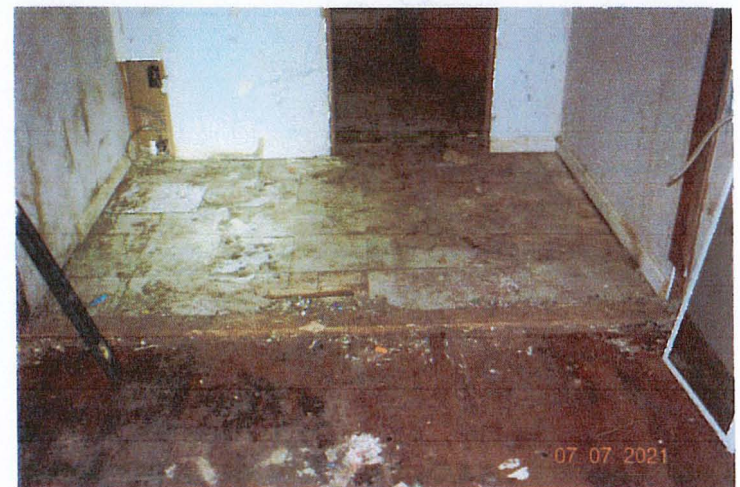
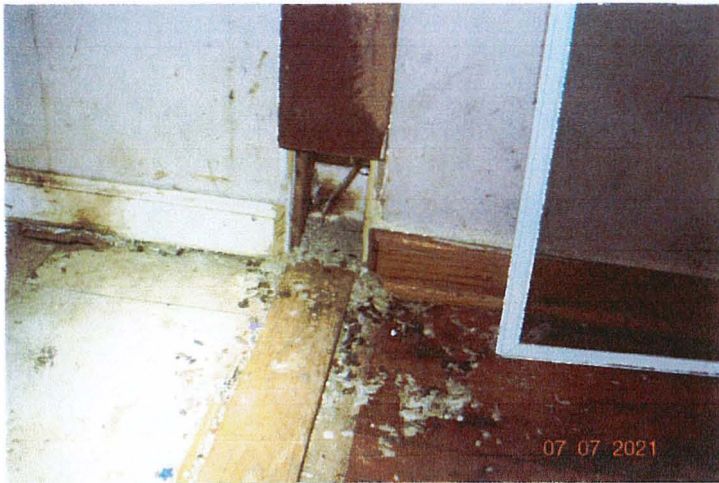
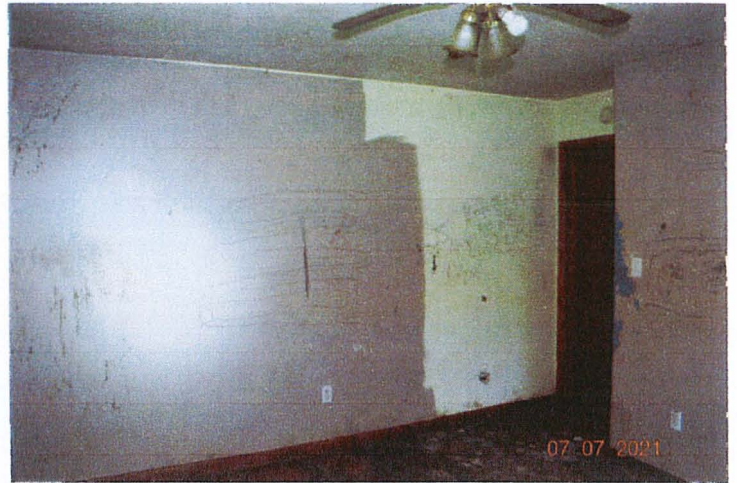
Photographs 17 through 19 detail the opening between the right rear bedroom and closet. The partition wall was previously removed to create this opening. As this wall was not load bearing, the removal did not result in sagging or displacement of the ceiling or roof frames. Photograph 20 displays the right front bedroom. The painted finishes were damaged by drawings and writings. Moreover, numerous holes were punched in the bedroom and hallway walls. Large amounts of insects and feces were also observed in these rooms.

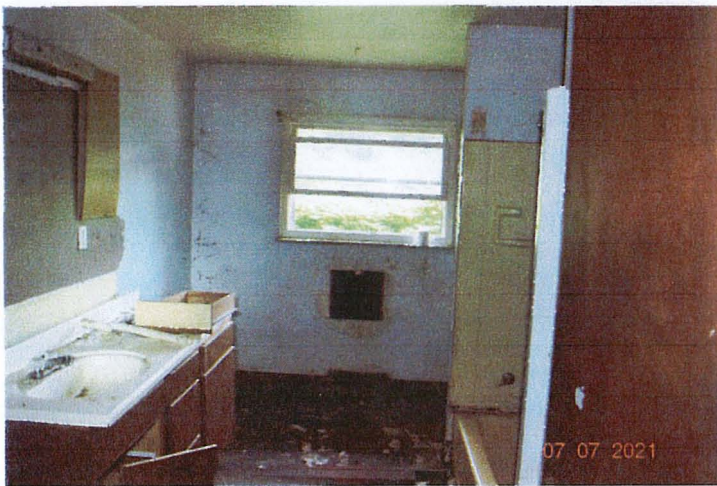
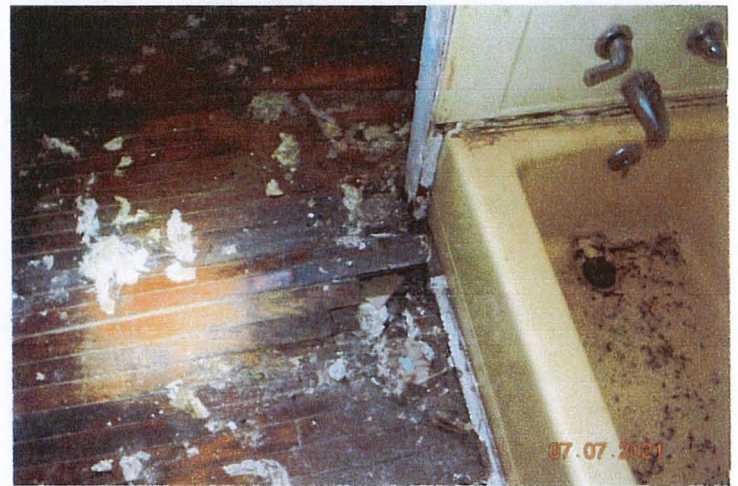
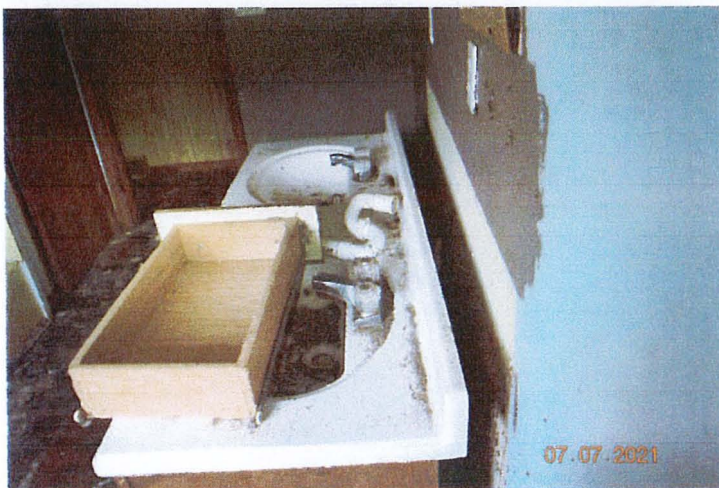
The bathroom is detailed in photographs 21 through 23. The hardwood flooring is damaged at the edge of the bathtub due to long-term water seepage. This damage is attributed to water spray during use of the tub and shower. The exposure to moisture caused the flooring to expand and buckle. Based on the reported living conditions of tenants in the home, this damage was likely obscured by trash and contents until the interior was cleaned. As shown in photograph 23, the sink was never connected to the supply and waste lines.

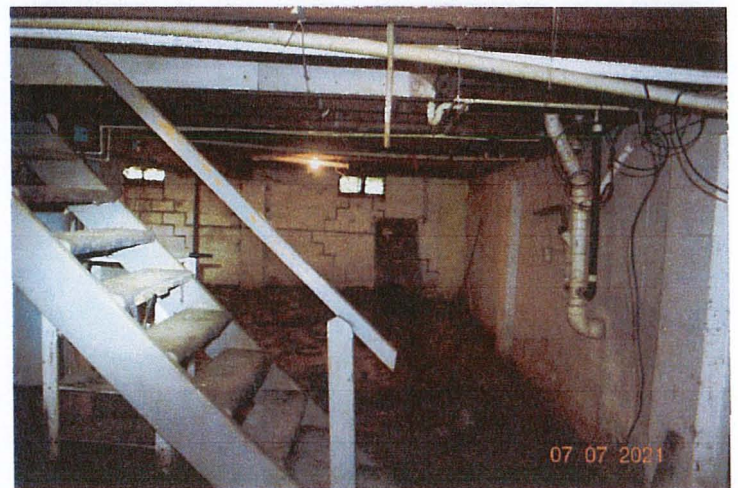
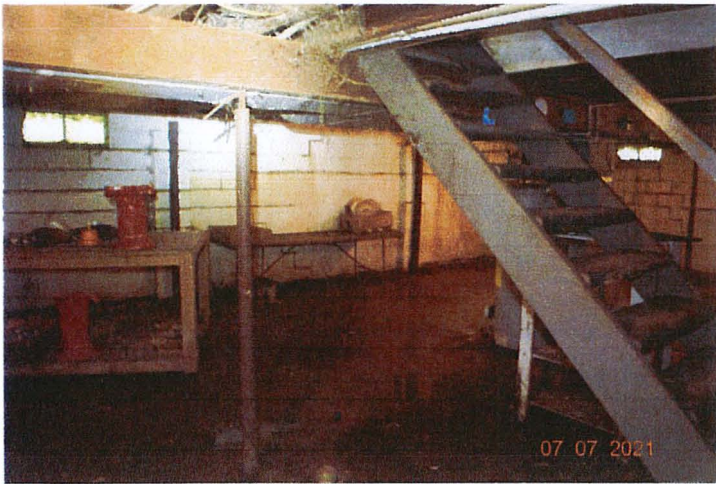
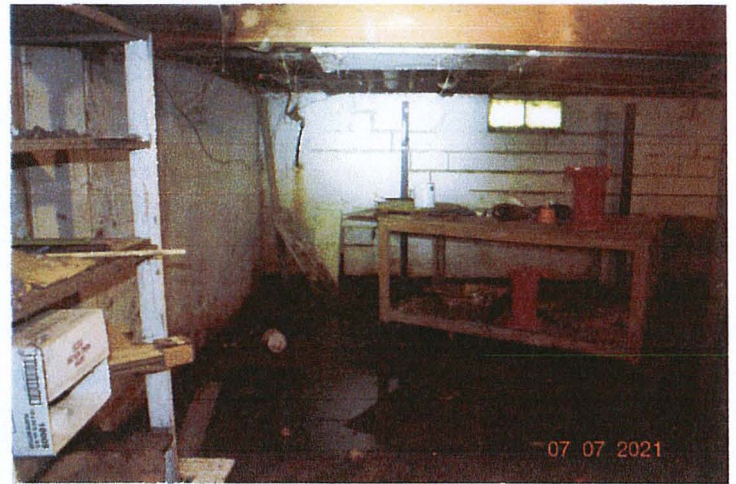
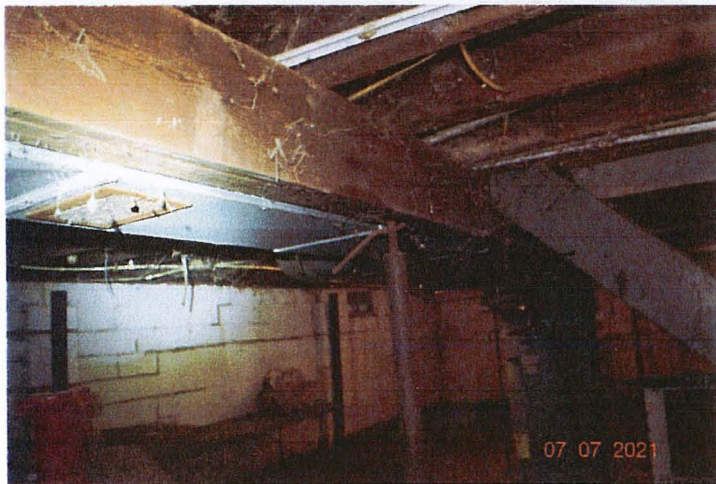
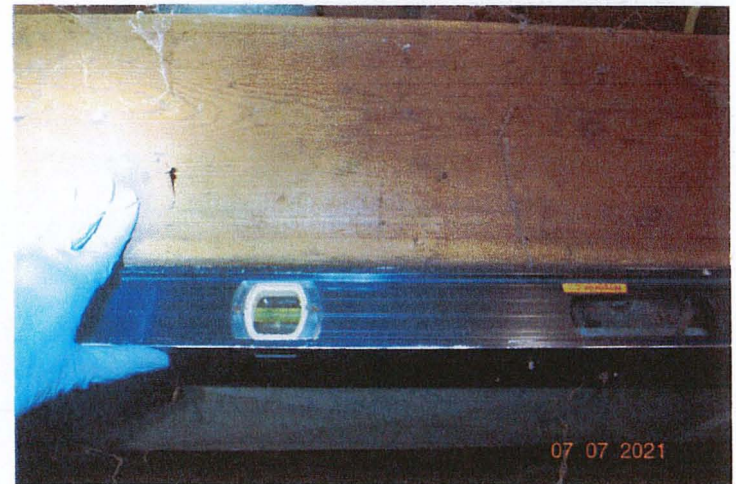
The basement is shown in photographs 24 through 26. Ground water continually accumulates over the basement slab. This seepage is associated with inadequate drainage and waterproofing around the foundation. The lack of maintenance of the surface ditches has worsened this issue. Photographs 27 and 28 detail the center girder at the left end of the home. The level measurements indicate sloping of the main beam due to differential settlement of the support posts. Excess loads from the trash and stored contents may have contributed to sagging of the floor system. However, the examination revealed no structural failures that warrant major repairs to the floor.

The seepage problem in the basement is severe and long-term in nature. Drainage improvements, including French Drains, diversion ditches, and sump pumps, are recommended to address this problem. Excess ground water around the subgrade foundation has resulted in bowing and cracking of the basement walls. These walls were not reinforced or grouted to resist these pressures. Interior supports composed of vertical I-beams or lateral tie-backs may be considered to address this movement. The past efforts to stabilize the rear wall with vertical beams were unsuccessful due to the failure to brace these members to the foundation and floor frame.

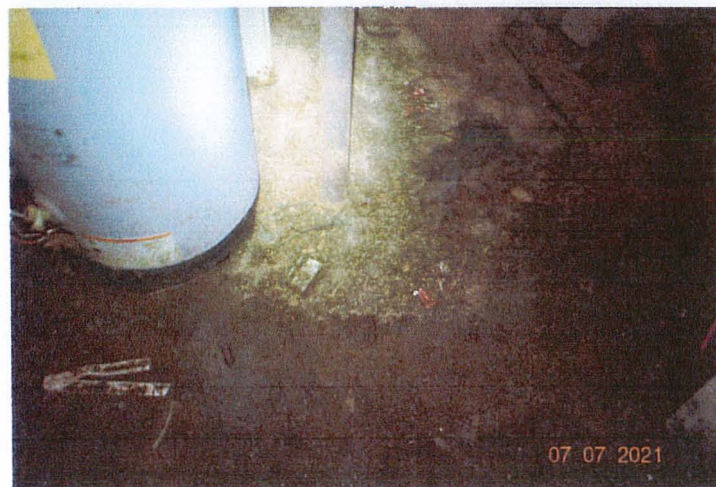
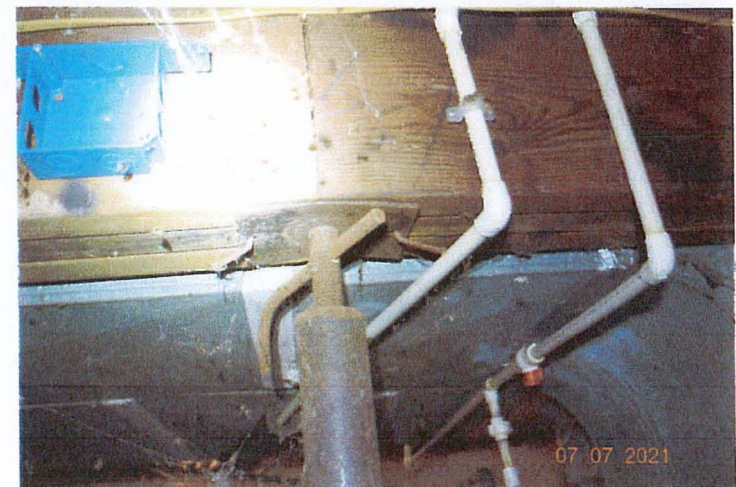
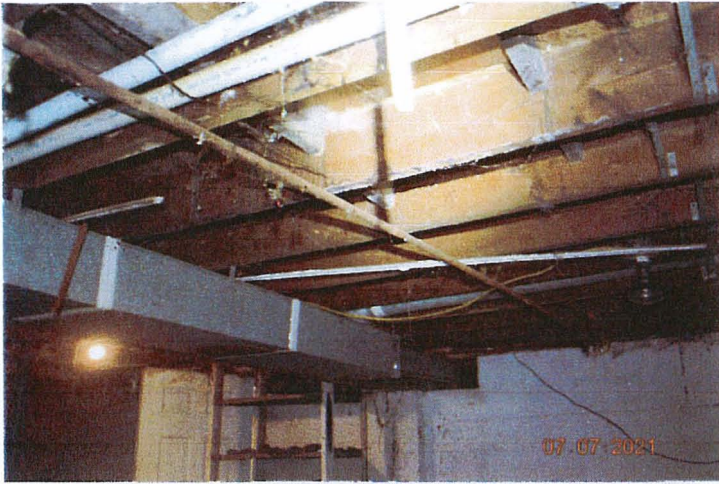
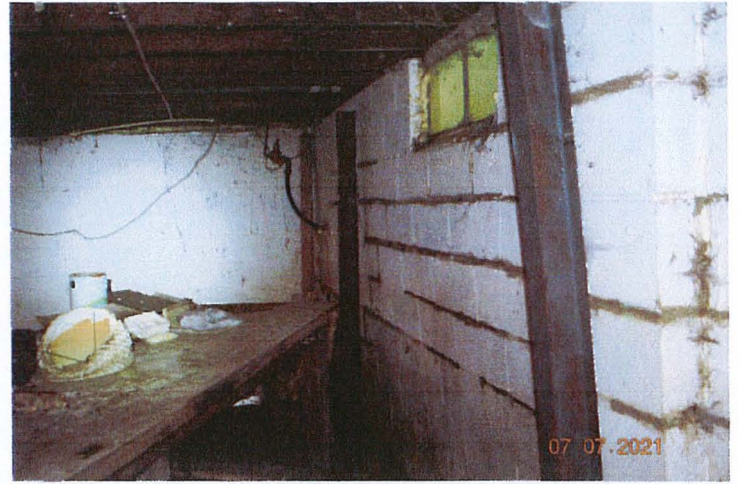
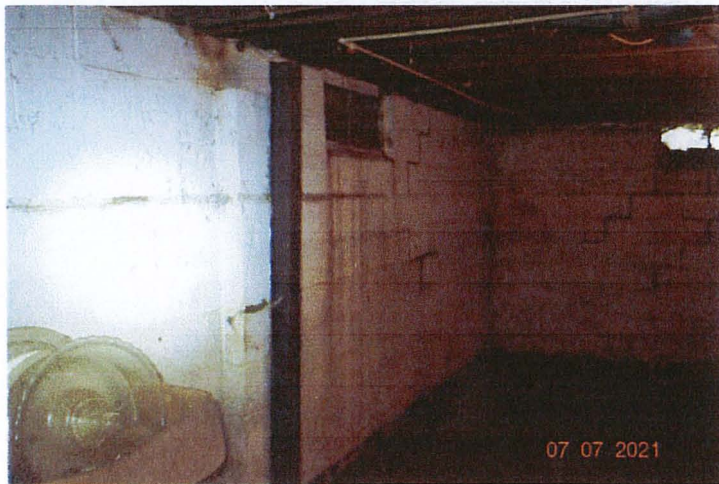
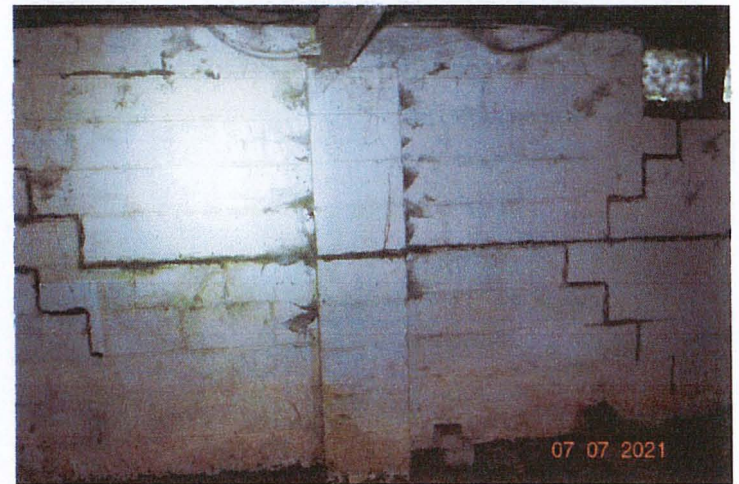
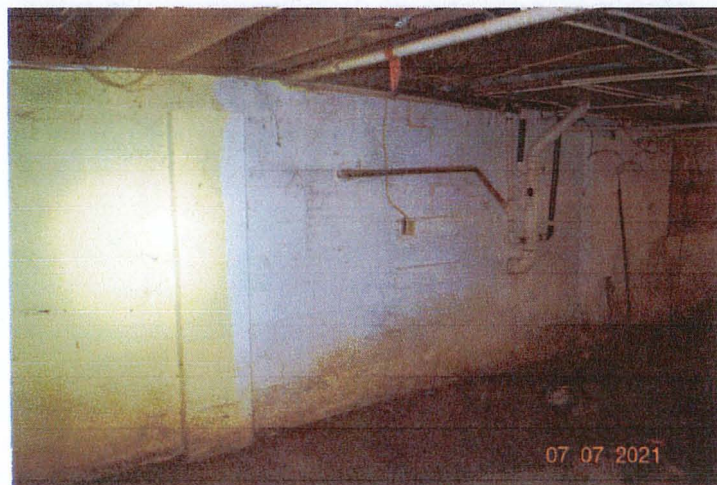
Photographs 29 and 30 detail a steel post under the girder. The post is continually exposed to moisture, which will lead to corrosion and structural failures. The joists under the dining room and kitchen are shown in photograph 31. These views reveal no visible splits or cracks in the joists that warrant structural repairs. The foundation walls, which are shown in photographs 32 through 35, are backfilled to an approximate height of six feet. The lateral pressures associated with the soil backfill and ground water have induced an inward bow in these walls. The nature of the movement and cracking indicates that the walls were not reinforced or grouted at the time of construction. The insured previously installed steel beams along the rear wall in an effort to stabilize the foundation. These efforts failed due to the lack of proper bracing to the foundation and floor frame.

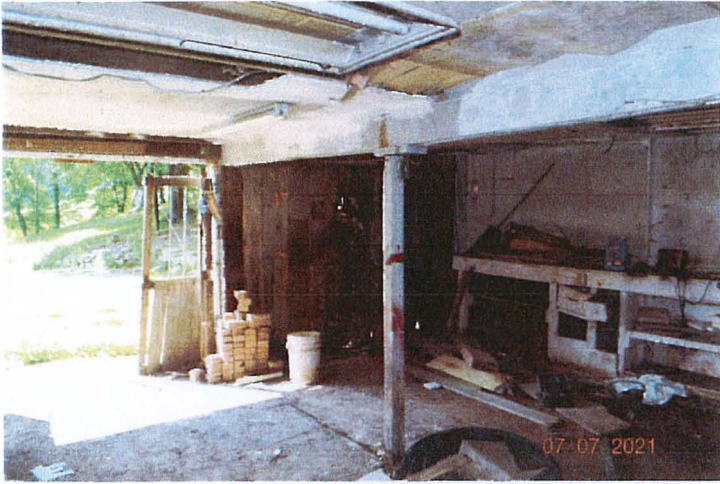
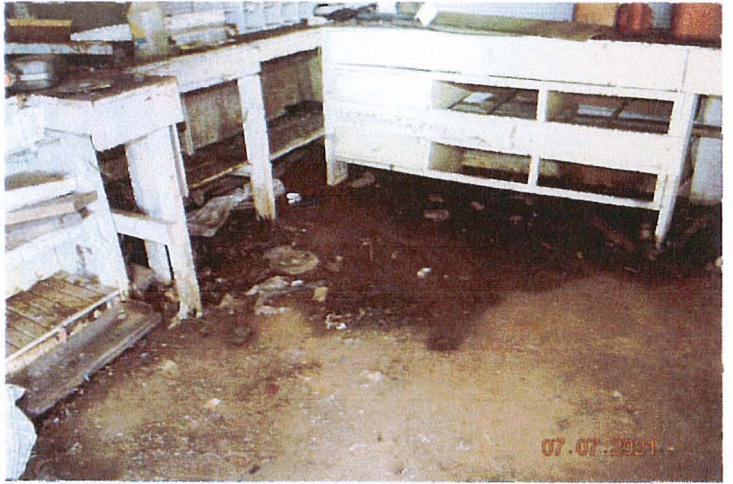
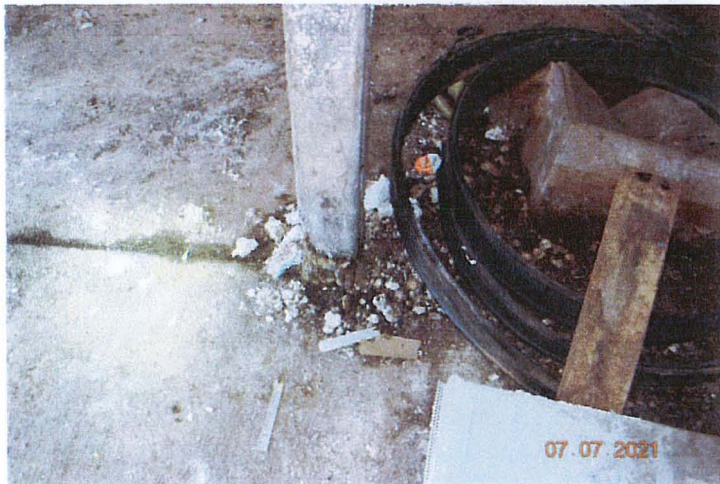
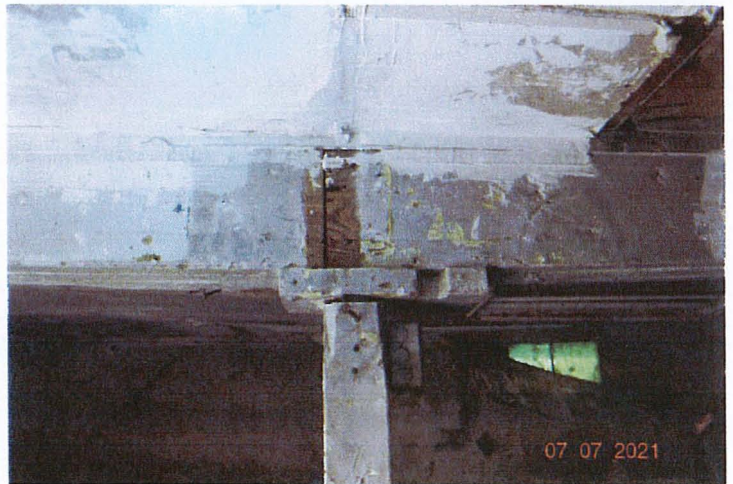
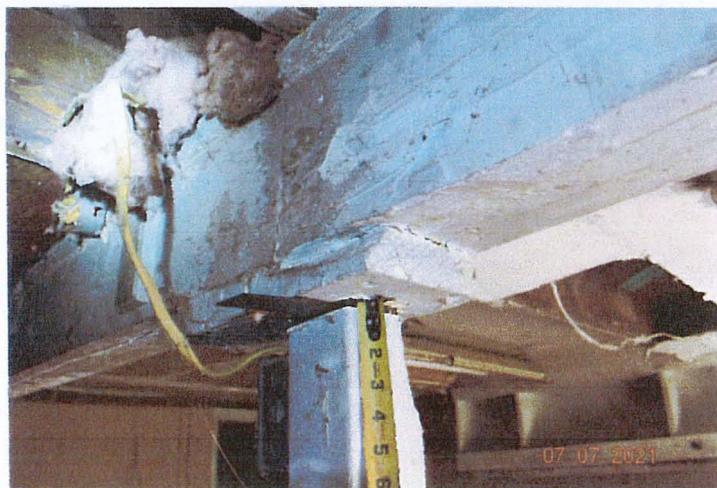
The garage is shown in photograph 36. Heavy seepage across the rear side of the garage is documented in photograph 37. This ground water has resulted in rotting damage to the tool benches and wall paneling. Additionally, a support post beneath the center girder has been rotted due to long-term water exposure. Photograph 38 details the base of the post, which bears directly on the concrete floor slab. The top of the post is detailed in photographs 39 and 40. The insured installed a metal shim, which raised the center beam by one-quarter of an inch. Additional shoring should be provided to remove loads from the rotted post and to permit raising of the floor. The beam includes plies that are not properly staggered. As shown, the outer plies have joints aligned with the center post. Additional plies should be provided on either side of the beam to increase flexural strength once the floor is raised to the desired elevation.
