**Towne Square
Facility Assessment
Parkersburg, WV**

Prepared for the Wood County Commission

May 19, 2003

Re: Towne Square Facility Assessment
Architect's Project Number 12527.112

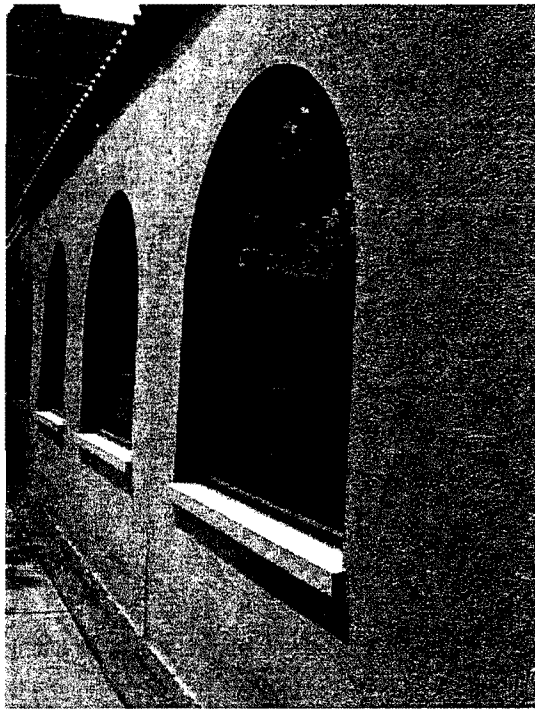
Typical Window – Exterior View

The windows are tinted, double pane, fixed glazing. In general the windows and skylights are in acceptable condition. On the day the site visit was conducted no condensation was visible between the panes of glass, and none of the windows were broken or cracked. The skylights were in similar condition, with no water damage from leaks evident.

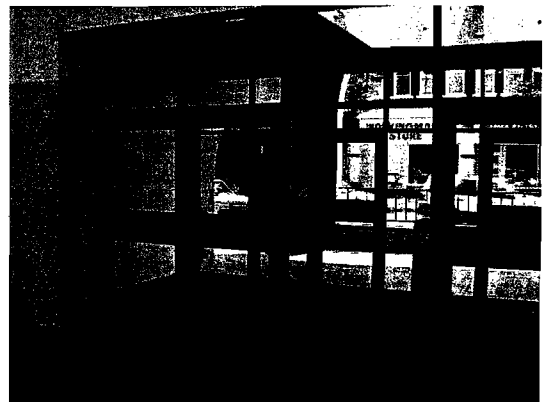
Storefront System at Entry Satisfactory
